**GENERAL INSPECTION REPORT (Non-NPDES)**

Name and Location of Facility or Pollution Incident Miller Farm	County Chester	Municipality West Vincent
--	-------------------	------------------------------

Conducted an inspection today (08/03/2011) of the Miller dairy farm. Inspection was conducted in response to a complaint received by the Department concerning improper manure storage and handling onsite in close proximity to a stormwater inlet. Inspection was conducted with, PADEP Steve Piller, Compliance Specialist. Access to the facility was granted by and the inspection was conducted with Kenneth Miller, owner.

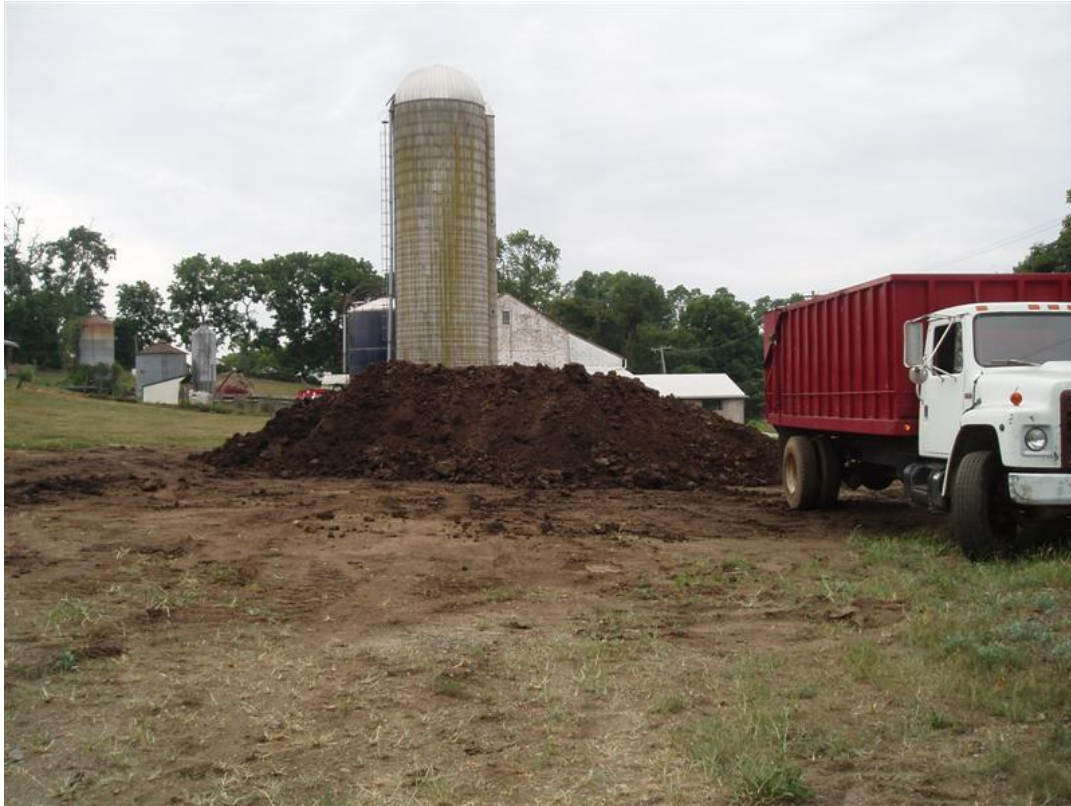
Upon inspection a manure pile was found located on the property in close proximity to Horseshoe Trail Rd.(see attached photograph)

The manure storage pile was found to be located in close proximity to a stormwater inlet located in the roadway.

**The location of the pile represents a source of potential pollution and constitutes a violation of section 402 of the PA Clean Streams Law.**

Manure storage pile located adjacent to Horseshoe Trail Rd.(on right in photograph)

The Department recommends the manure pile be removed or moved to a location onsite that that would prevent direct runoff from the pile to waters of the Commonwealth. Discussions with Mr. Miller included the possible construction of a manure storage facility in the location of the pile that would be under roof and bermed to prevent exposure to stormwater runoff.

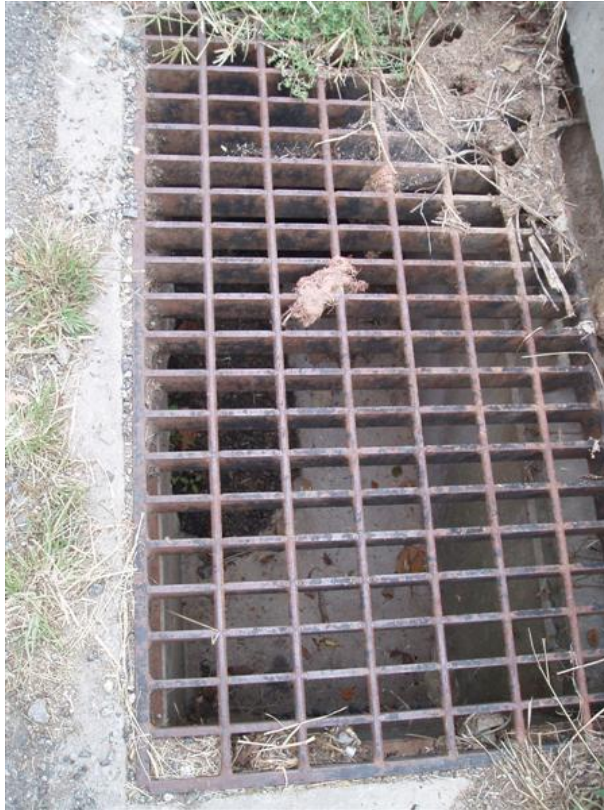
The stormwater inlet was inspected and found to be dry and clean of solid manure. No staining was visible in the inlet at the time of the inspection. (see attached photograph)

Stormwater inlet

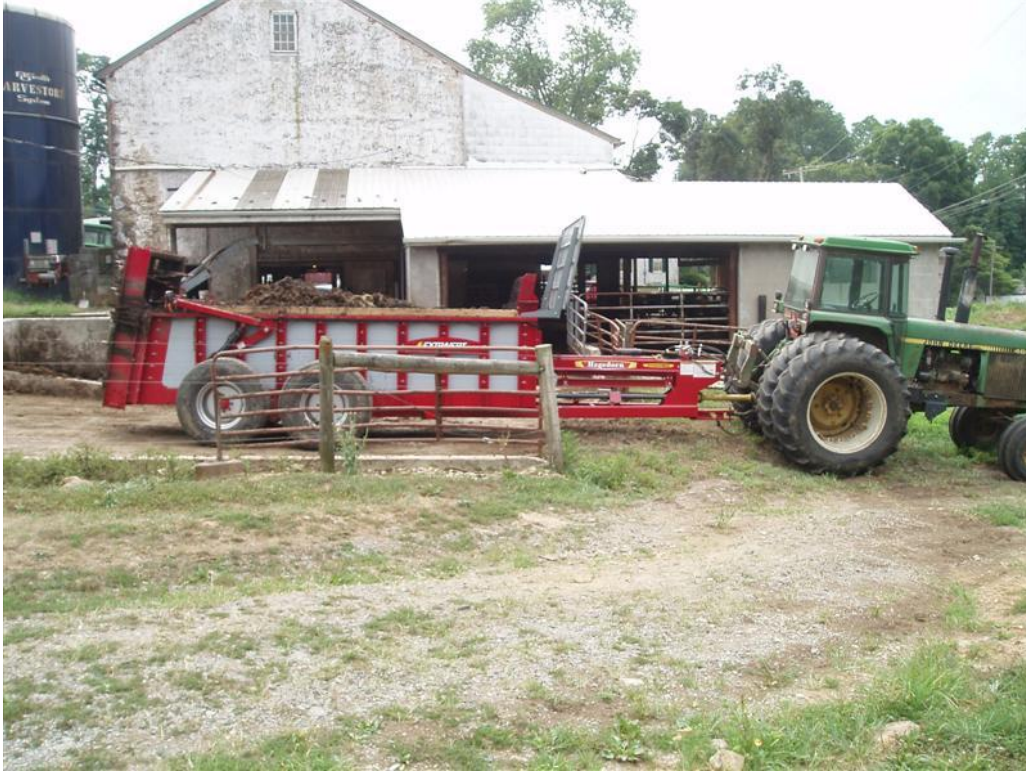
Mr. Miller stated at the time of the inspection that 21 truckloads of manure have been hauled from the site since Sunday (07/31/2011). Manure hauled from the site is taken to a CSA facility to be used as compost. Manure from the pile has also been spread on a portion of the 700 acres of property that is leased by Mr. Miller with the onsite manure spreader. (see attached photograph)

Onsite manure spreader
